FISHING CREEK WATERSHED FLOODING ASSESSMENT AND MITIGATION STUDY

County of Columbia, Pennsylvania

June 2022

HRG
Herbert, Rowland & Grubic, Inc.
Engineering & Related Services

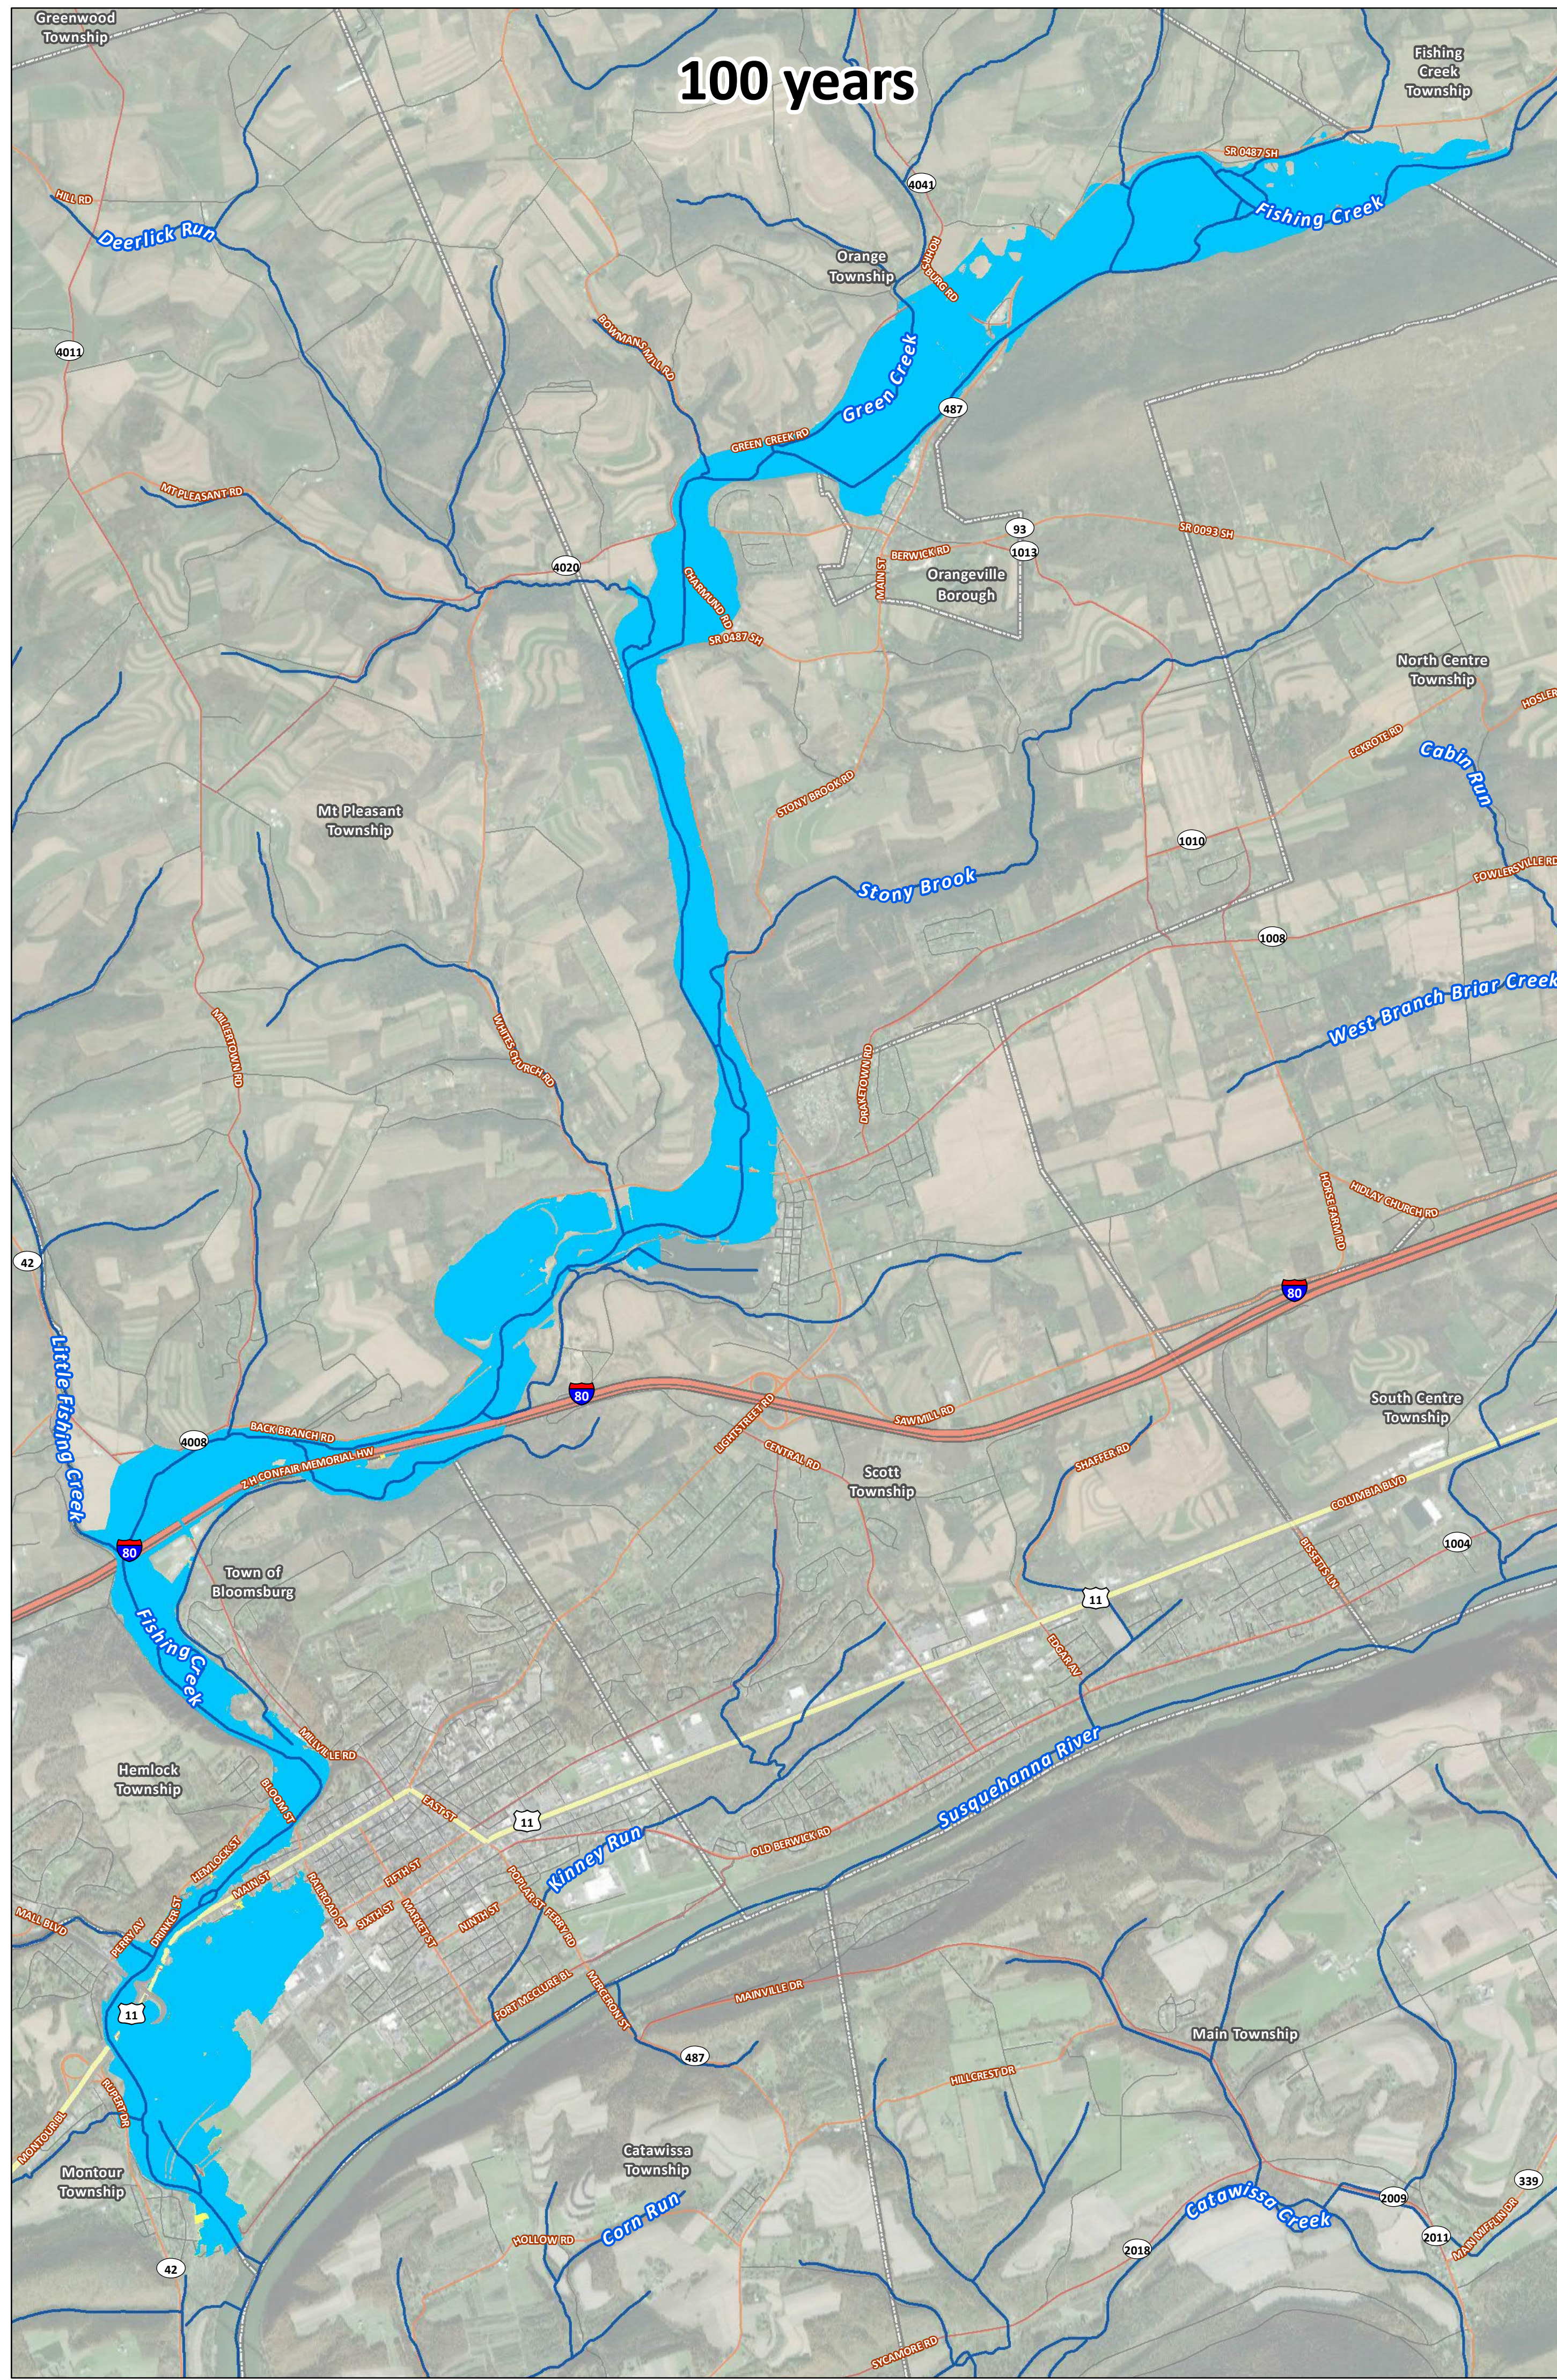
**Fishing Creek
Agriculture to Meadow**
Columbia County, Pennsylvania

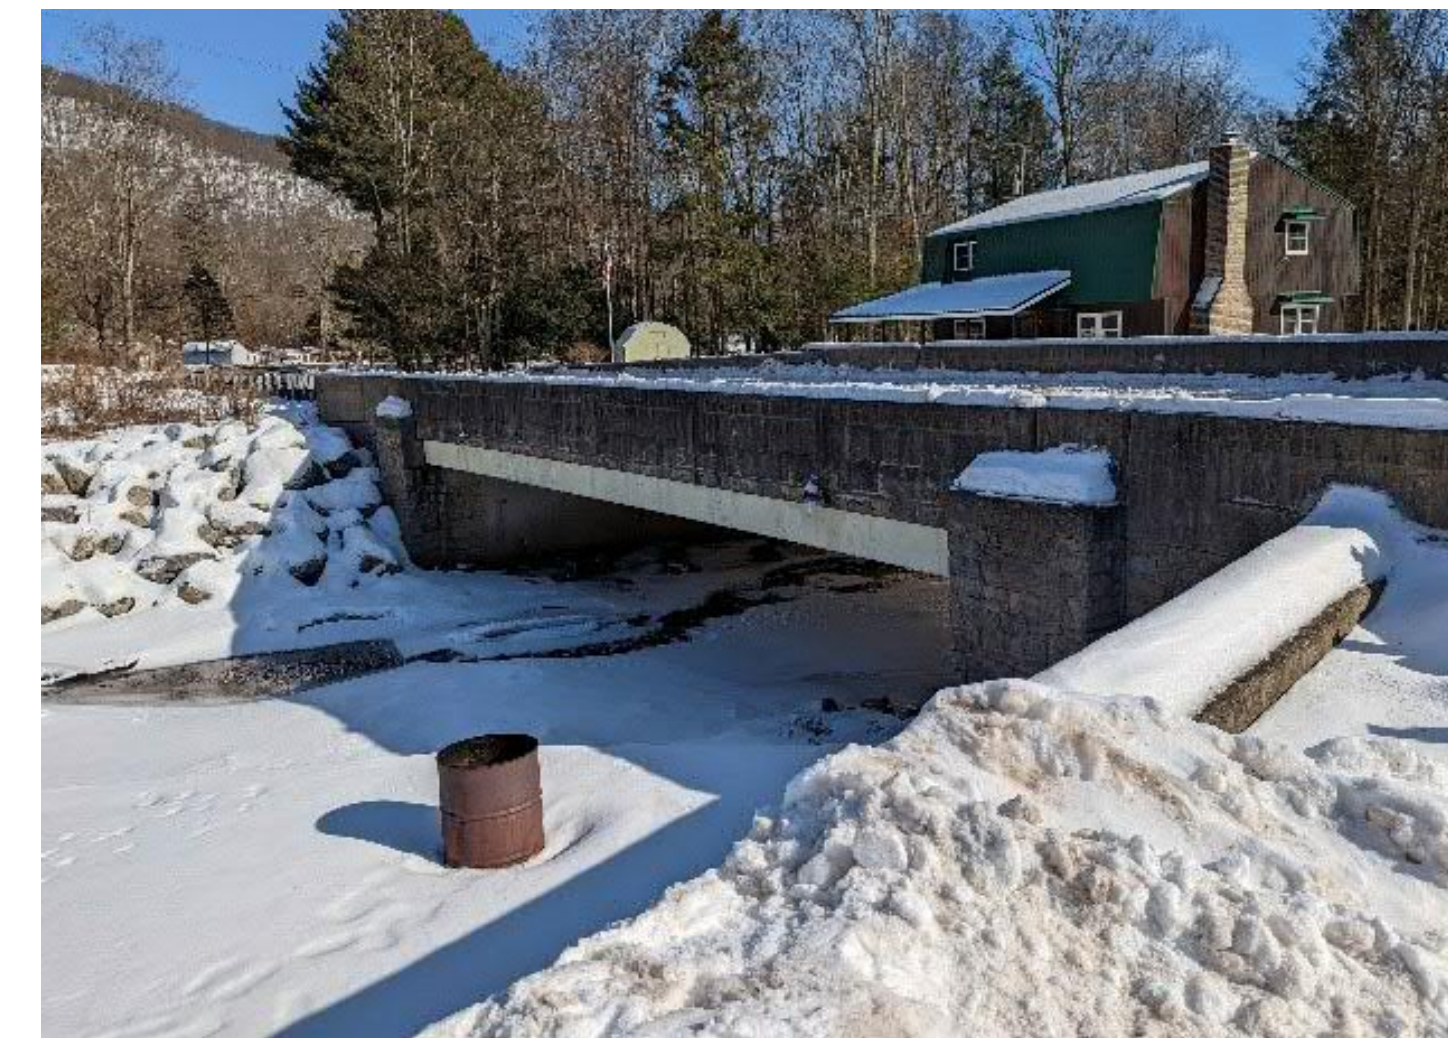
3 UFC-3 : CENTRAL ROAD FLOODING

Problems: Flooding/Sedimentation
Mitigation Concepts: Culvert Replacement / Bridge Replacement

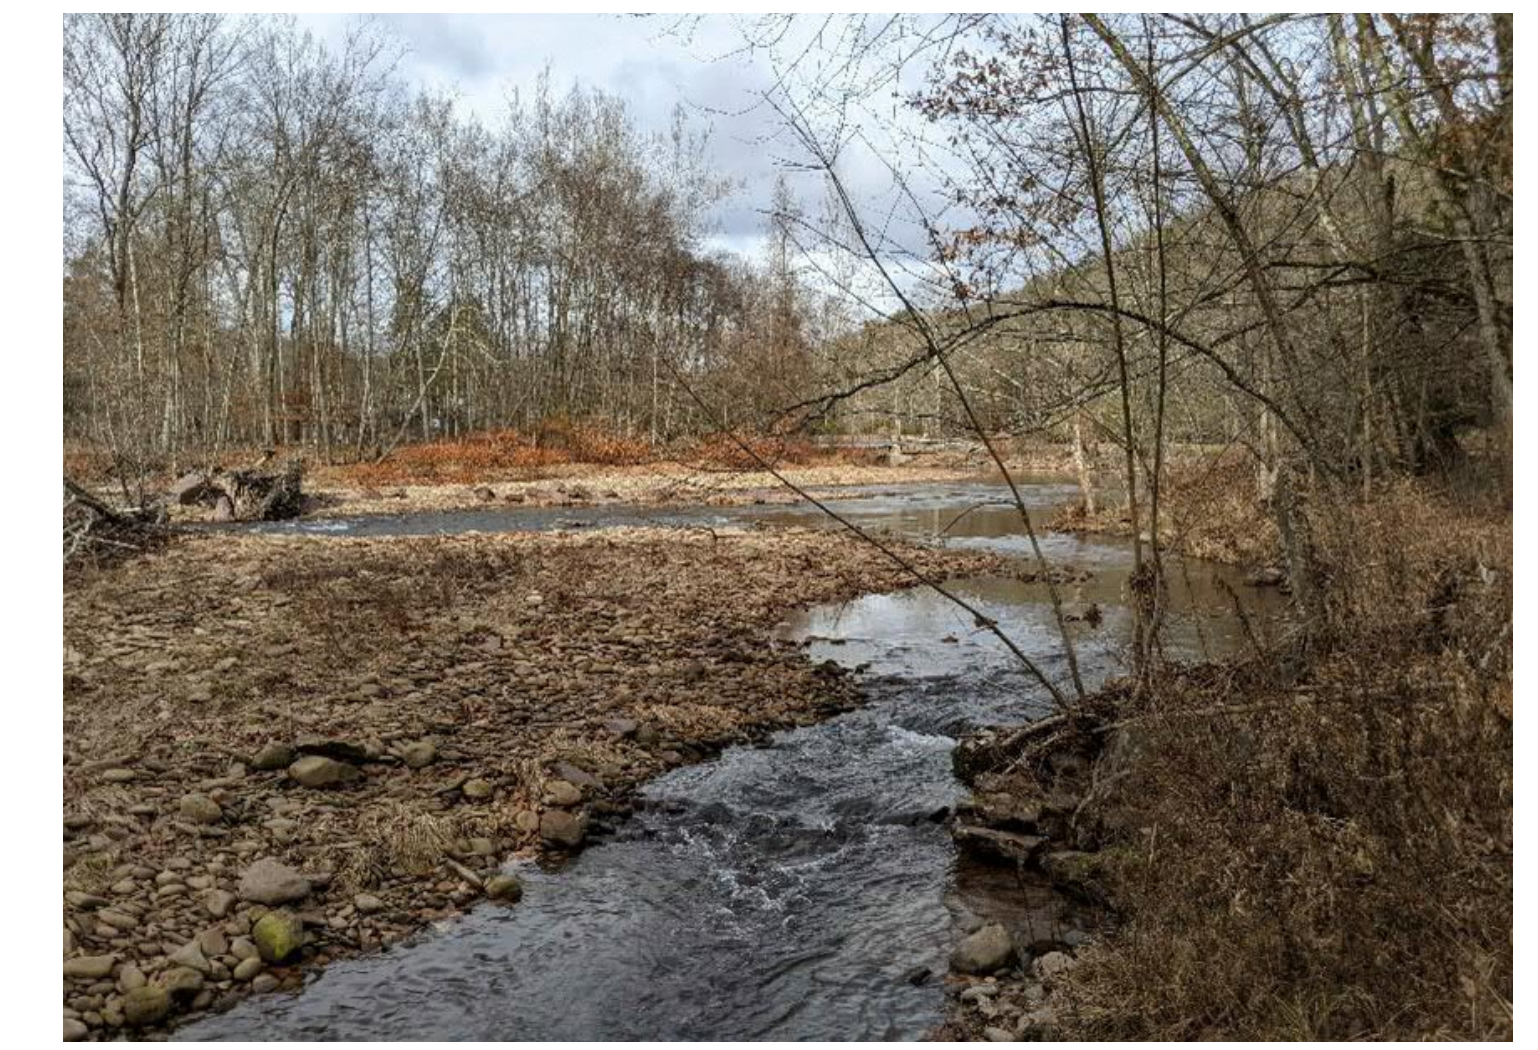
7 UFC-7 : CAMP LAVIGNE ROAD BRIDGE

Problems: Flooding/Infrastructure
Mitigation Concepts: Vegetation/ Debris Management

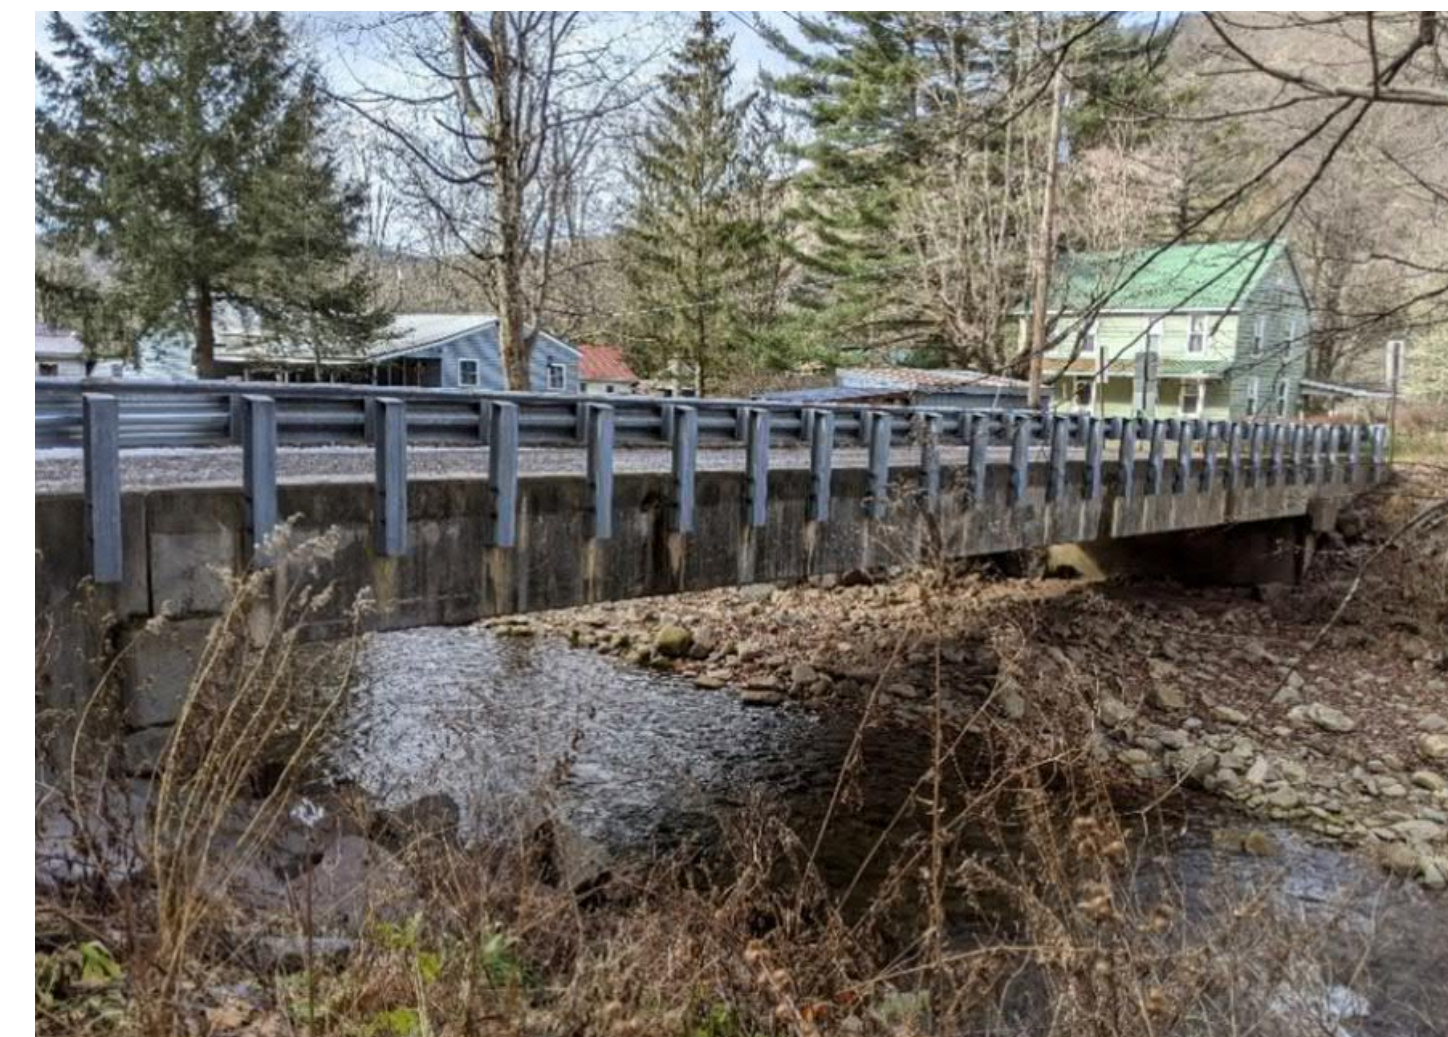
4 UFC-4 : JAMISON CITY ROAD FLOODING

Problems: Flooding/Sedimentation
Mitigation Concepts: Sediment Removal/Bridge Replacement

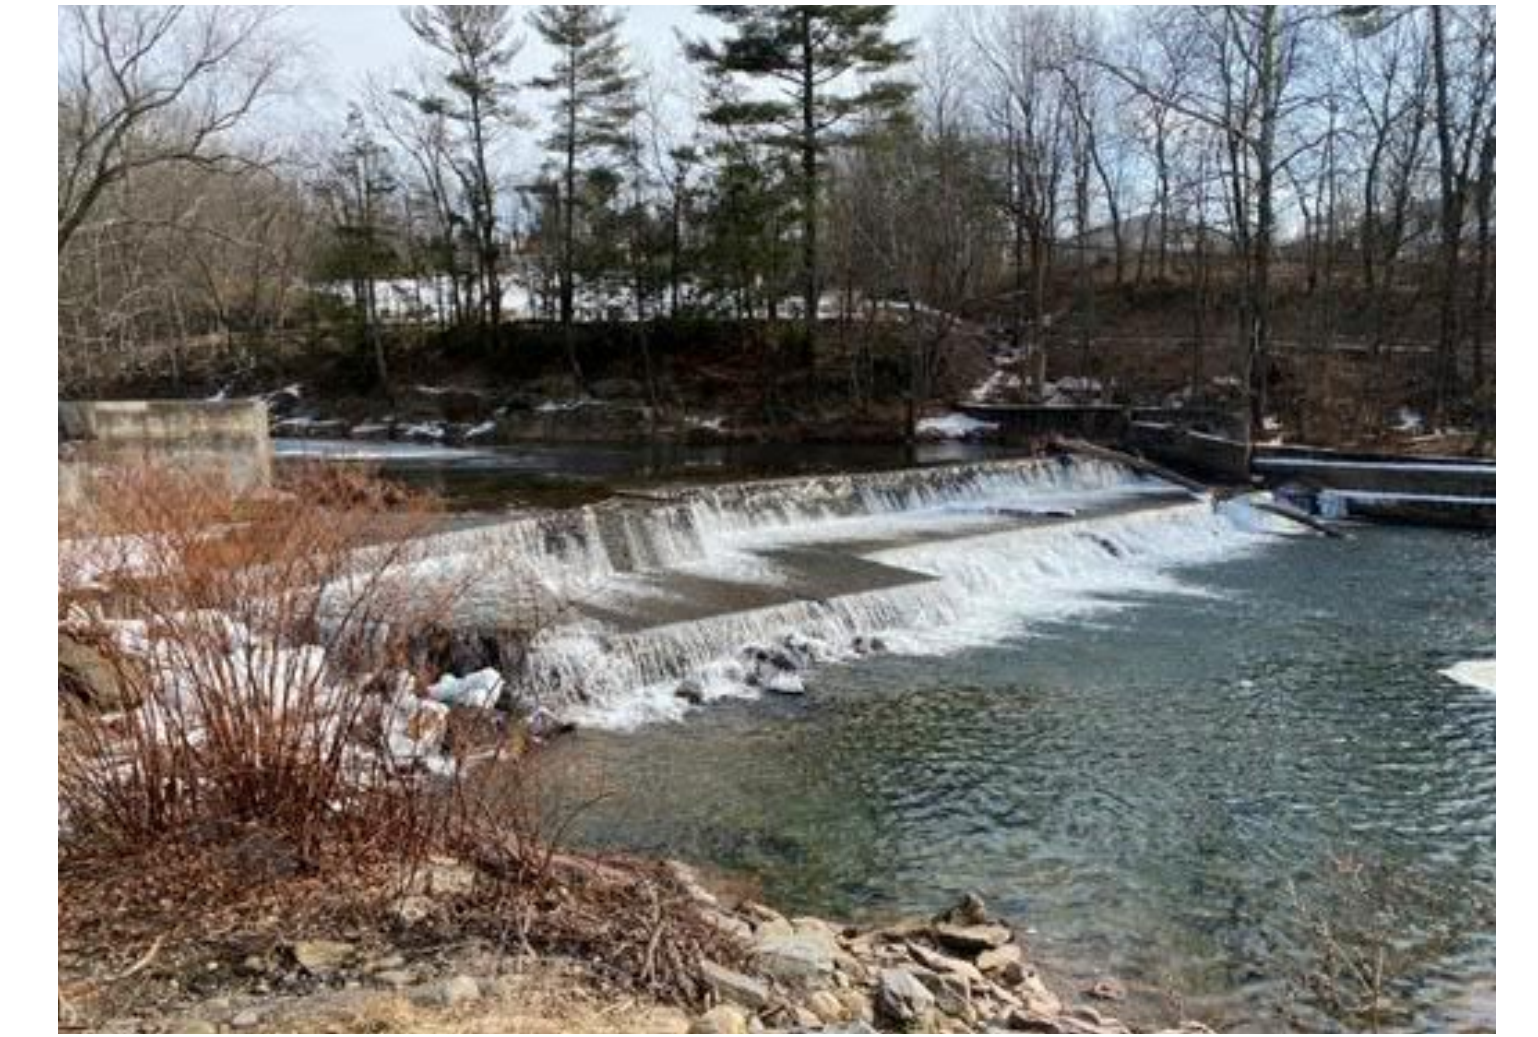
8 UFC-8 : BENTON BOROUGH FLOODING

Problems: Flooding
Mitigation Concepts: Dam Removal/ Levee/Roadway Reprofiling

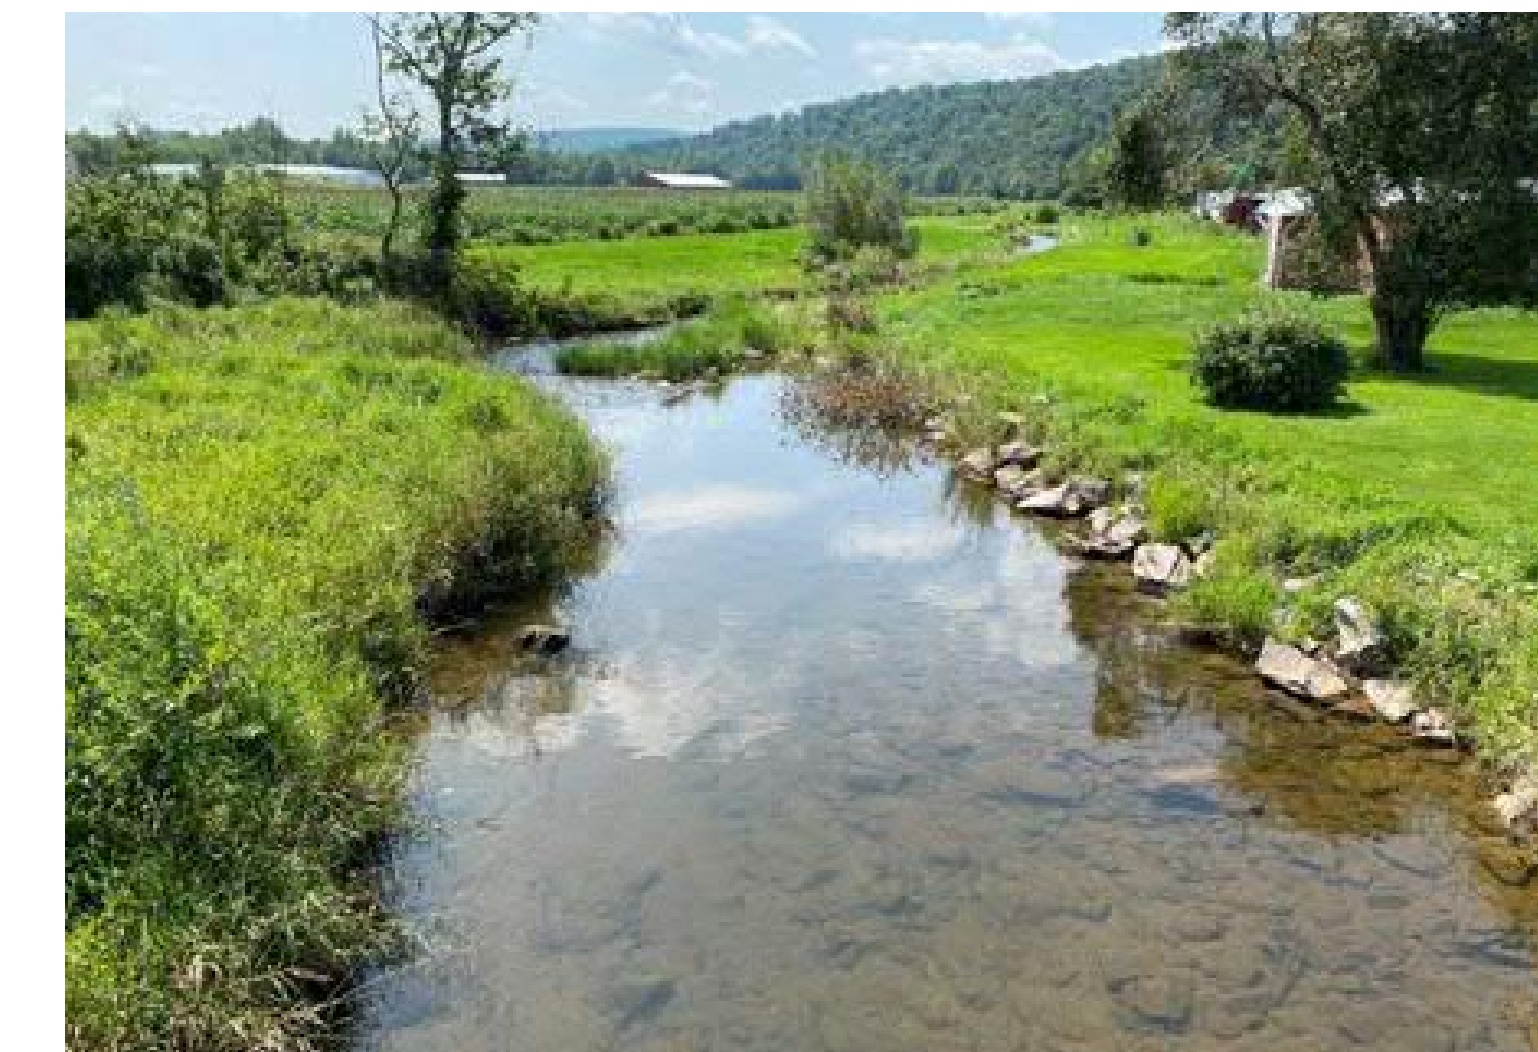
9 UFC-9 : DISTILLERY HILL ROAD FLOODING

Problems: Flooding
Mitigation Concepts: Bridge Replacement/ Sediment Removal

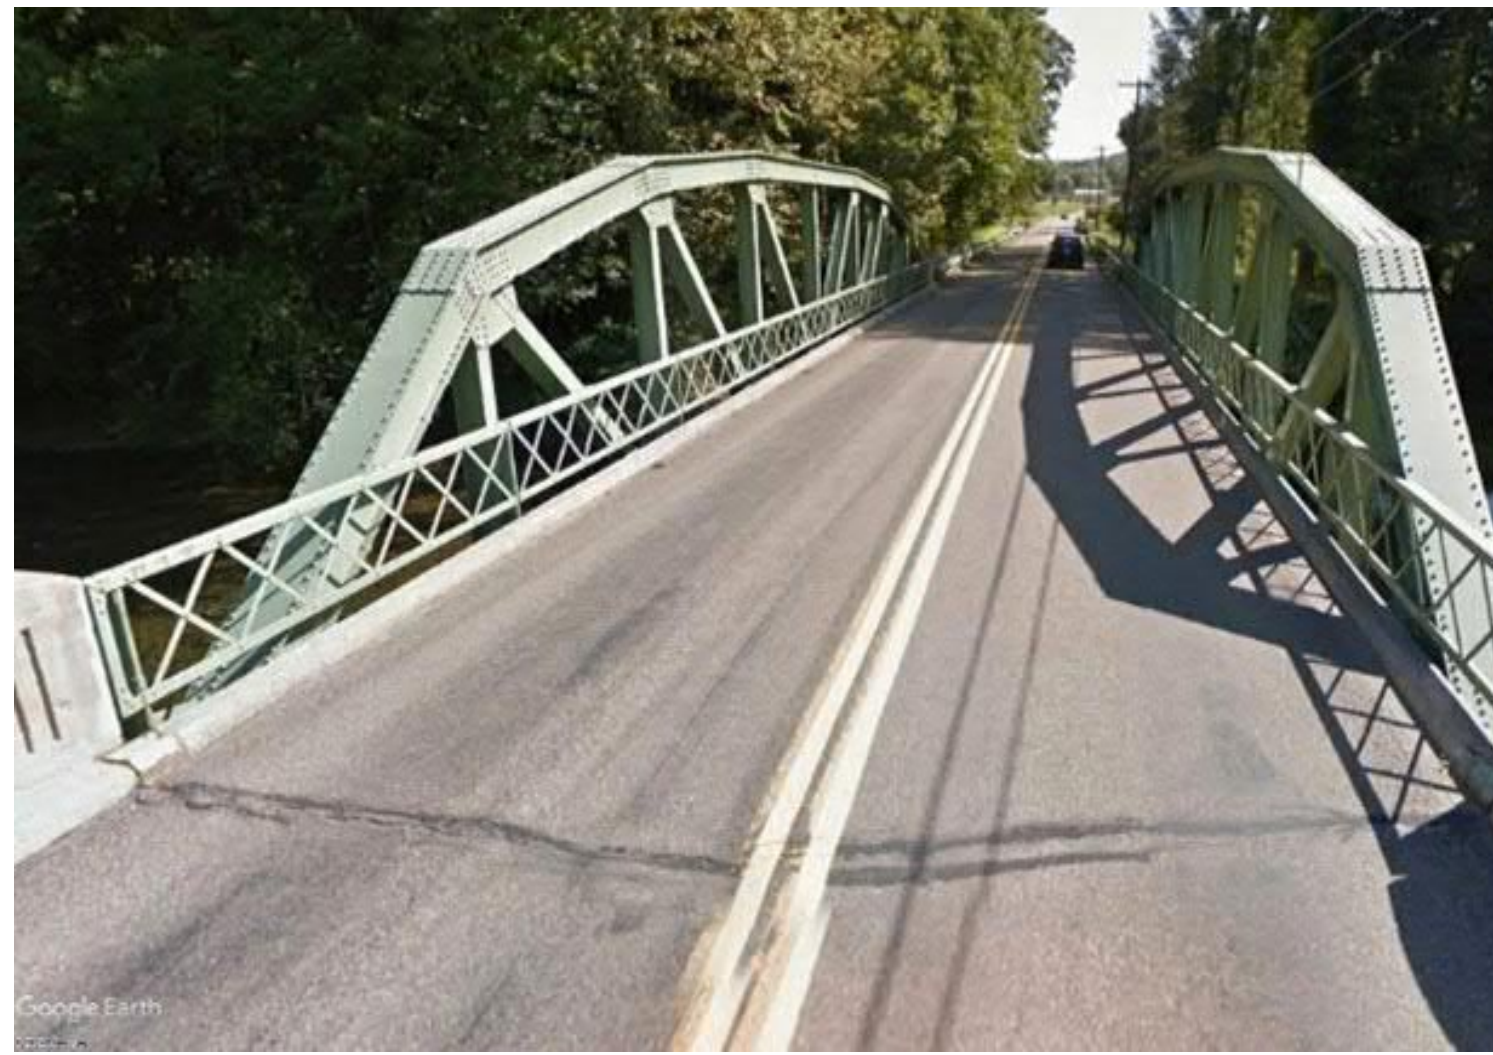
5 MFC-5 : ZANER BRIDGE ROAD FLOODING

Problems: Flooding/Sedimentation
Mitigation Concepts: Bridge Replacement/
Sediment Removal

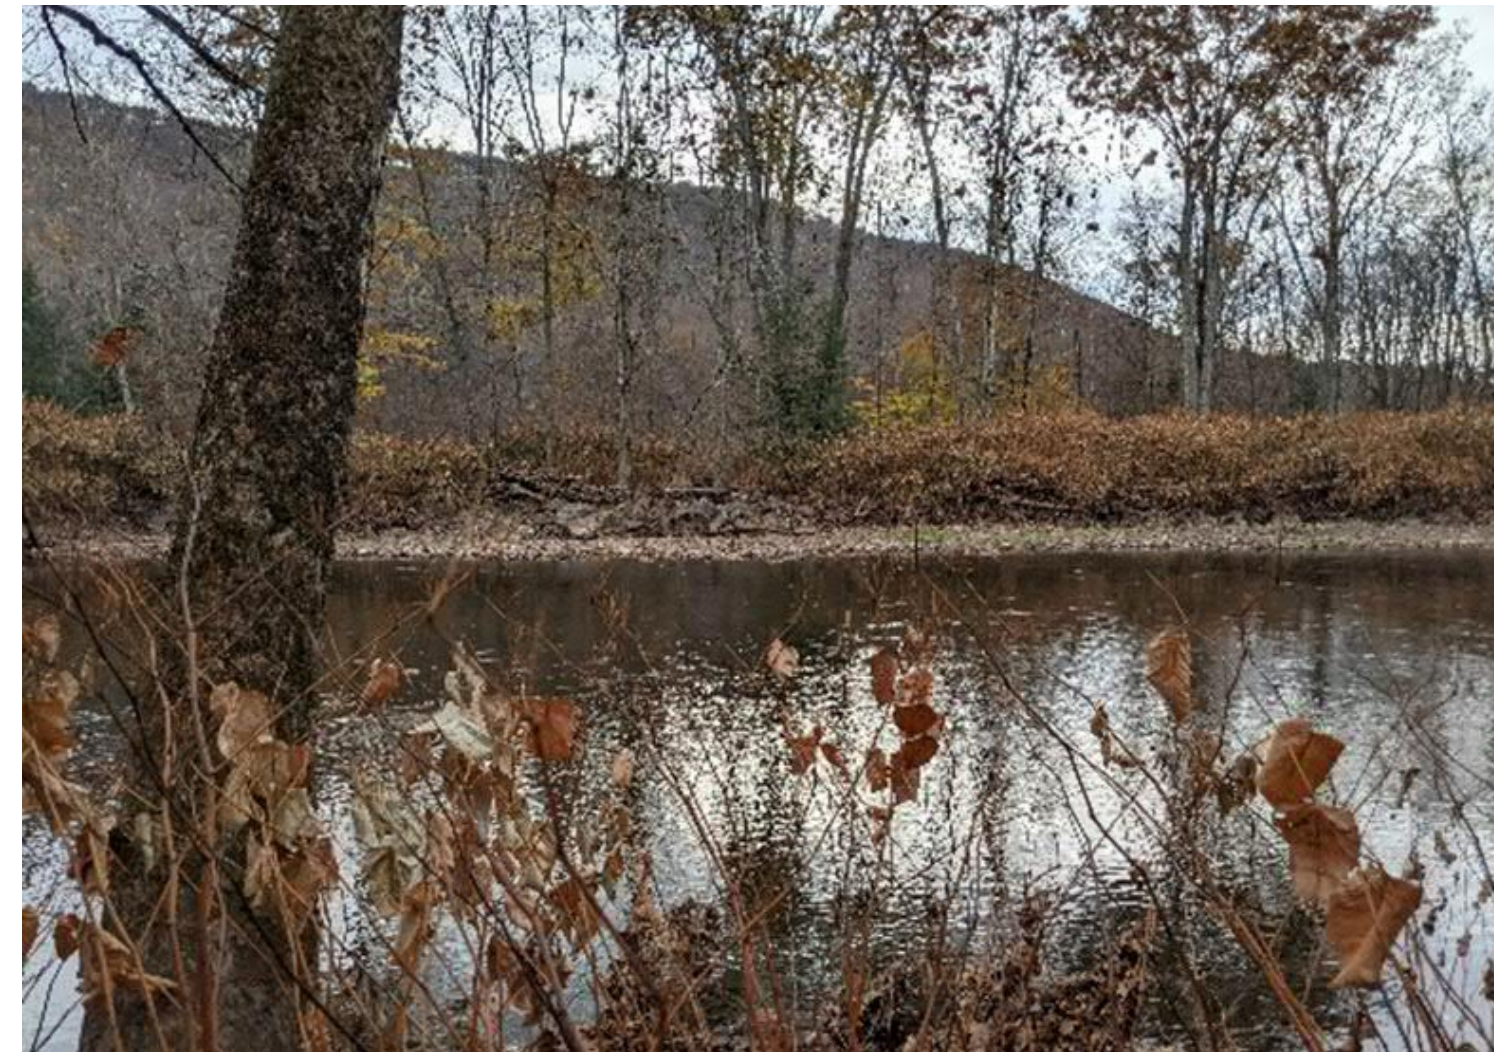
9 MFC-9 : MOORE'S GROVE ROAD FLOODING

Problems: Flooding/Sedimentation
Mitigation Concepts: Streambank Stabilization &
Property Buyout/Relocation

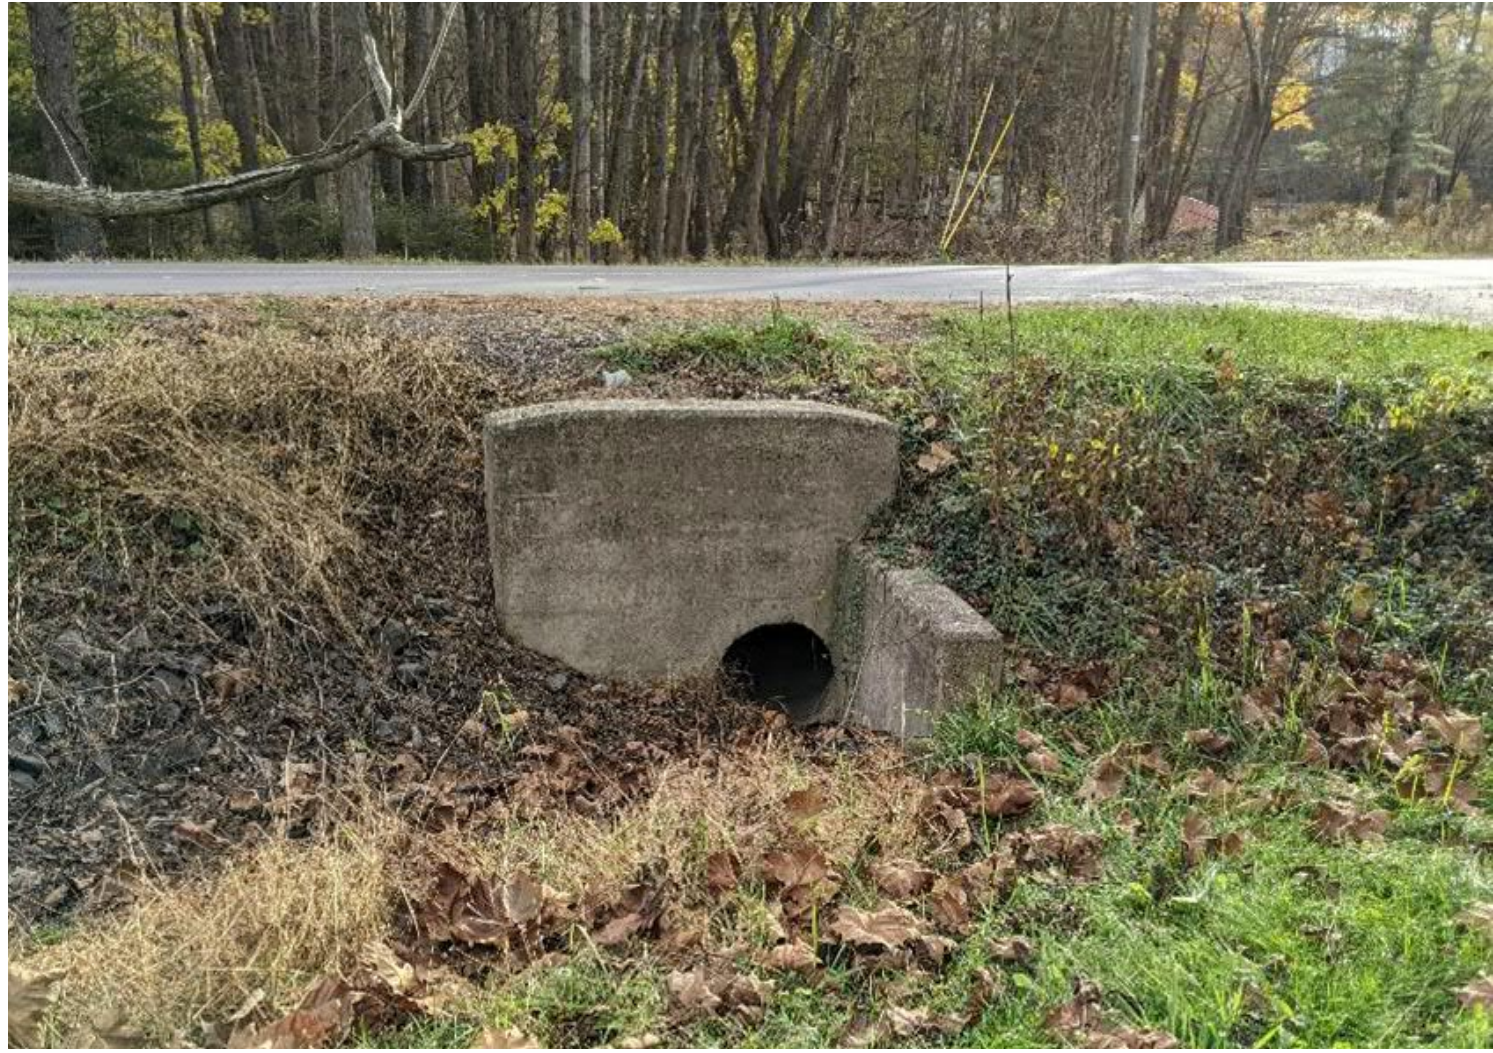
6 MFC-6 : WINDING ROAD CULVERT

Problems: Flooding/Sedimentation
Mitigation Concepts: Culvert Replacement
